BALL MILL TRUNION GRINDING

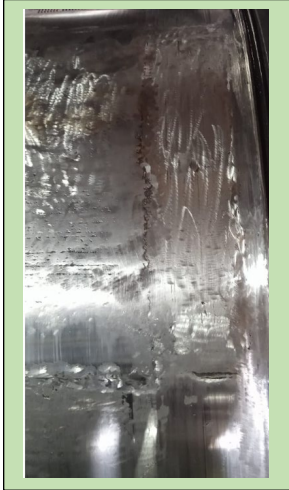
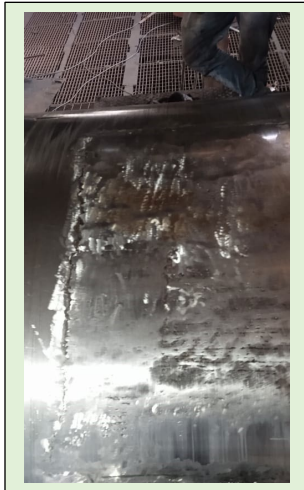
1. Trunion journal got worn-out due to damage of seal and ingress of raw material in the trunion bearing, leads to damage of the trunion journal surface.
2. Thickness of trunion reduced considerably beyond repairs at four positions along the circumference.

TRUNION SURFACE BEFORE

1. Removal of worn-out surface, circumferentially at the damaged area using minimum heat input.
2. Care taken to ensure minimum distortion of the journal during the repairs (cutting and welding).

3. Preparation of "V" groove at the 4 positions.
4. Fabrication of 60 mm thick ring of 500 mm width and diameter 1628 mm.
5. Machining of ring on the outside to ensure the circularity and required surface finish.

6. Window cut damaged portion of the ring and refurbish on the trunion.
7. During the patch, it is ensured to maintain the straightness throughout the length.

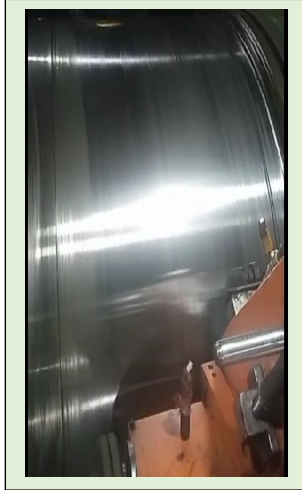
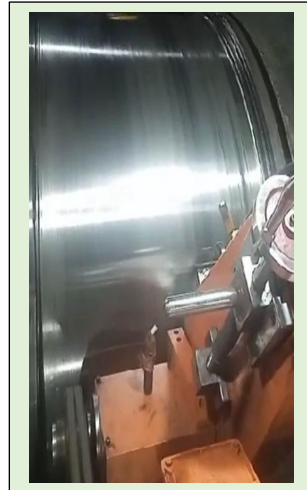
1. Mill lift observed 0.3mm whereas earlier recorded was 0.1mm, under the similar conditions.
2. Mill operates on auxiliary 0.3 rpm for 10 hrs, no temperature rise observed in journal bearings.
3. Mill taken on full rpm for 4 hours, observed operates in normal (*no abnormalities observed*).
4. Finally mill charged with 70% grinding media and started, runs smoothly with normal feed.
5. Further grinding media charged gradually up to 100% and observed mill operates normal.

TRUNION SURFACE AFTER GRINDING

1. ASEPL had especially developed precision grinding machine for similar grinding assignments.
2. Grinding machine installed at appropriate positions, parallel to the rotating axes at an angle @ 40 °.
3. Mill rpm in inching drive is 0.3, increases to 1 and maintain @1 rpm for the grinding.
4. Suitably select grinding stone specification and depth of the grinding executed at every phase.
5. Material removal on the trunion is 3.5 mm radially.
6. Final reading as out of roundness +/-0.35
 - a. Straightness throughout length +/-0.7 TO +/- 1.0
 - b. Surface finish up to 25 micron i.e. 30 to 35 rms value.

1. After completion of the grinding:
 - bearing liner scrapping carried out to blue match the trunion surface.
2. The blue match contact pattern taken as:
 - 100% at center along the length and width 300mm Rest of the portion is non-contact.
 - Bearing clearance, radial of 0.35 to 1.7mm, gradually increase as per the standard.
